Changing fashions in the crown jewel of the modern glass furnace

As glass manufacturers worldwide experiment with hydrogen, biofuels, electric and hybrid melting to meet sustainability targets, the full effects of these new melting techniques on existing furnace crowns are not yet understood. Fused-cast refractory supplier Monofrax is adapting to the challenges presented by these new technologies, says Valerie Weber.

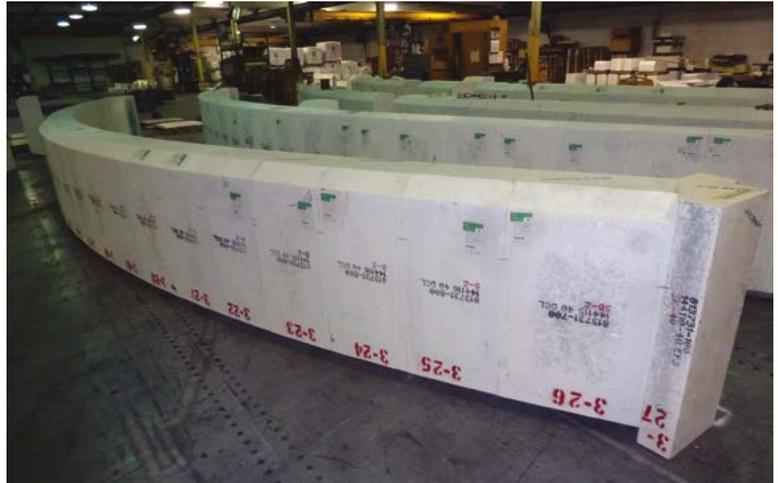
View of crown blocks set for floor inspection.

As dramatic and impressive as a crown looks when sprung, floor inspection allows for a more thorough and accurate evaluation of the blocks. Preassembly in rings on the floor results in a better fitting crown. It also proves to be more cost-effective for both the customer and the supplier.

With floor assembly, the critical plane surfaces between rings can be controlled to a much greater degree. Blocks remain square. Field construction results are improved. Building with adjusted blocks creates difficulties for the construction crew. Floor assembly results in a better-fitted crown.

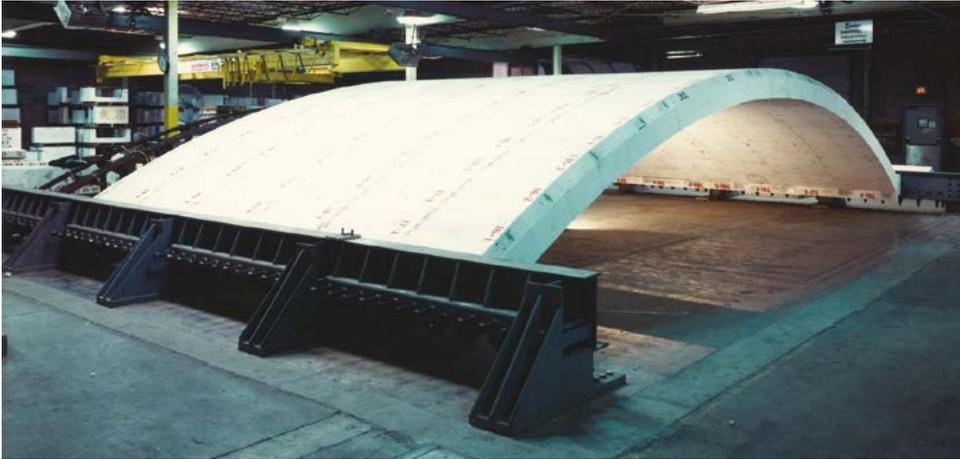
Crown blocks sprung on steel supports for customer inspection.

When a preassembly is sprung,

as the building progresses, minute adjustments are made to the minor faces to provide a planed surface between rings. Two objectives drive these adjustments.

1. The levelling of the block can create a slight out of plumb condition on the vertical face.
2. If one end of the block runs up the centre slightly faster than the other end, 'saw toothing' results. If this isn't taken care of immediately in preassembly, it multiplies.
